2006-2007 Jeep Liberty Front Door Power Window Regulator Repair Kit

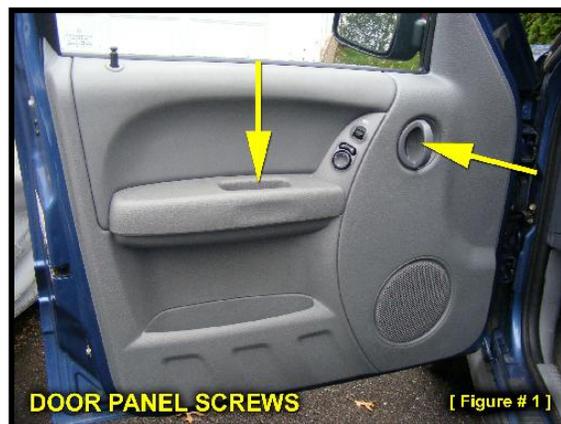
The first step is to remove the door panel. There is a Phillips head screw in the armrest grab handle and another behind the door handle. (Figure 1) The screw behind the door handle is hidden by a small cover which you will need to gently pry out using a small flat head screwdriver. After removing both screws, you can disengage the door panel trim clips by working your way around the edge of the door panel, pulling it away from the door. You may need to pry something under the edge to get it started. Auto parts stores sell a special tool that is designed for this purpose but a flat head screwdriver will also work. (If you use a tool of some type, be careful not to scratch or chip your paint.) There are eleven trim clips running around the perimeter of the panel - their locations are shown in Figure 3. Once you have pulled all of them loose, you can lift the panel slightly to allow the top lip to clear the window slot.

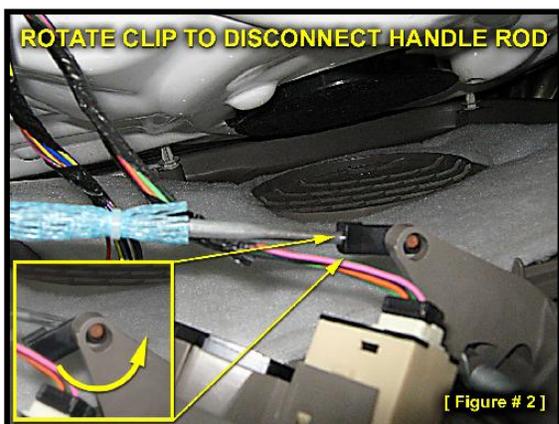
You should now be able to pull the panel far enough away from the door to reach behind it and disconnect the inside door handle actuating rod. To do so, simply unclip and rotate the plastic lock which will allow the metal rod to slip down and out of the hole. (Figure 2) Unplug any electrical connectors from the back of the switch module and then lift the door panel up off the door lock knob and set it aside. Remove the three Phillips head screws holding the speaker in place (Figure 3), pull it away from the door, disconnect its electrical connector and then set the speaker aside.

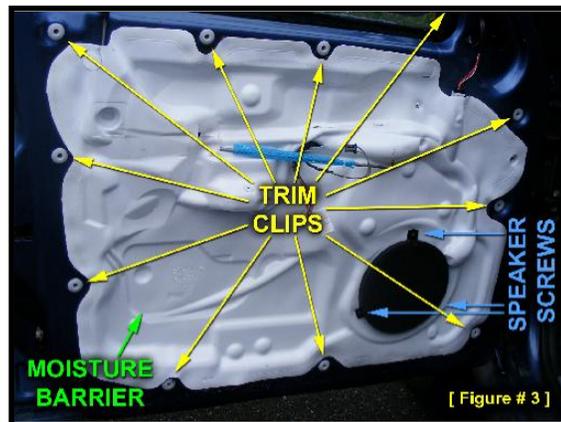
The moisture barrier (Figure 3) is glued to the door using a non-hardening, tar-like sealant. You can remove the moisture barrier by simply peeling it away from the door. Go slowly so that you don't rip the barrier and be careful not to get any of that sticky adhesive on your nice clean upholstery! Once you have peeled off the moisture barrier, lay it somewhere out of the way with the adhesive side facing up. (If the adhesive becomes contaminated with dirt or dust, this will reduce its effectiveness and make it more difficult to stick the barrier back on later.)

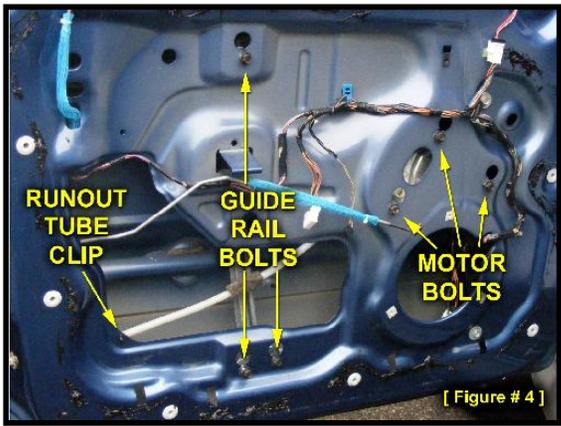
There are six bolts holding the window regulator in place: one at the top of the guide rail, two at the bottom and three on the window motor. Their locations are shown in *Figure 4*. Loosen these bolts – you don’t need to remove them completely, just backing them out several turns is sufficient. Reach through the speaker opening and disconnect the electrical connector from the motor by sliding the red lock on top to the side and then squeezing the locking tab at the top rear of the connector while pulling the plug and socket apart. On the bottom edge of the large opening in the door, the runout tube is clipped to a hole in the inner door skin using a plastic anchor. (*Figure 4*) Disconnect it by squeezing the prongs of the anchor together and pushing it through the hole.

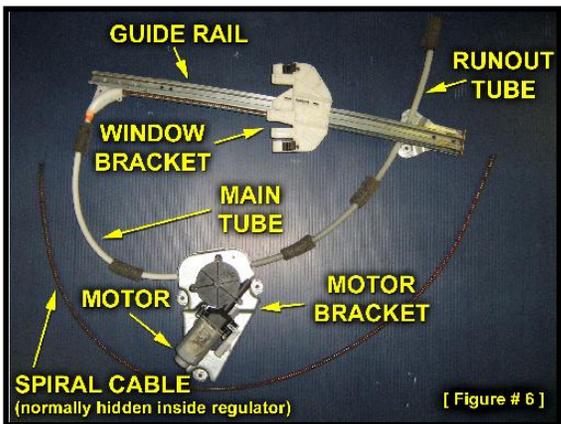
Figure 6 shows what the window regulator assembly looks like when removed from the vehicle. Various parts of the regulator are labeled for your reference.

(Note: For a diagram showing the window regulator parts referred to in this document, please see Figure 6 on the second page.)

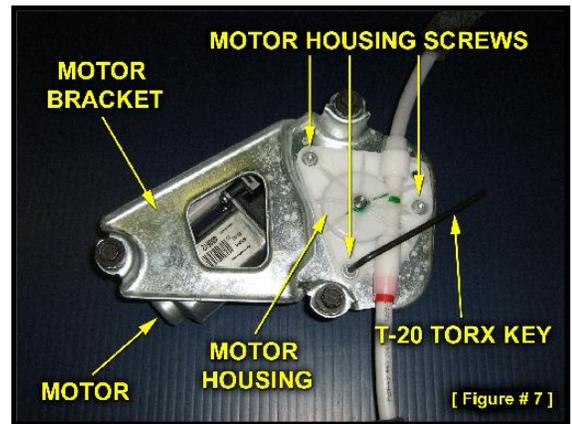
Use the Torx tool provided in this kit (or a T-20 Torx driver) to remove the three motor housing screws (*Figure 7*) then set the motor and the motor bracket aside.

Using the three Torx screws that you removed earlier, reattach the motor to the motor housing, making sure to sandwich the metal motor bracket between the two. If you are not sure about the orientation of the motor, bracket and housing, you may find it helpful to study *Figure 7*. (Note: The window regulator pictured in *Figure 7* is for a left front door, so if you are working on the right front, bear in mind that your regulator will be a mirror image of the one shown in the photo.) If the gear has fallen off the motor shaft, put it back in place. The metal gear connects to a plastic piece which has three “legs” on it. These legs must mesh with a rubber “star washer” at the bottom of the motor shaft in order for the plastic piece and gear to be fully seated. *Figure 14* shows what the gear should look like when it is properly installed in the motor, as well as an example of what it looks like when the gear is not fully seated.

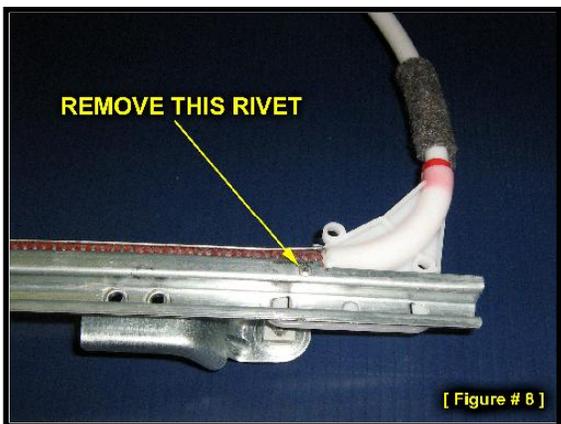
At the top of the guide rail (where the main tube attaches) you will find a small rivet. (*Figure 8*) Remove the head of this rivet. You can use a drill, grinder, cutoff wheel, Dremel® tool or even a hand file. A quick removal technique is to put the sharp edge of a chisel against the head of the rivet and strike with a hammer. Whatever method you use, be careful to only remove the head of the rivet itself; do not damage the metal guide rail.

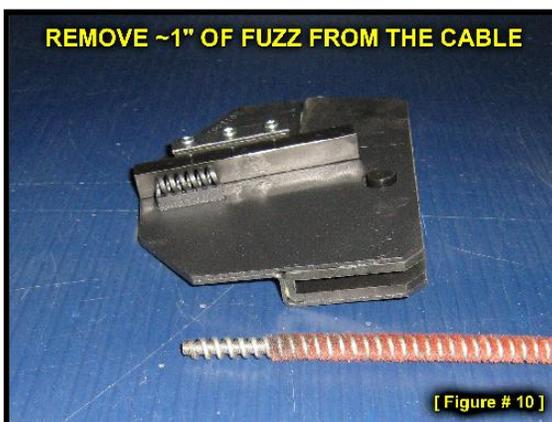
You may find it helpful to pry the main tube and guide rail apart using a small screwdriver as shown in *Figure 9*, but be careful not to damage the plastic. Pull the spiral cable out of the guide rail and main tube and remove any bits of plastic which might be attached to the end of the cable. *Note: If you cannot remove the spiral cable because it is stuck in the main tube, use a pair of pliers or vise grips to grab the end of the cable that is sticking out of the runout tube and rotate the cable in a counter-clockwise direction to unscrew the cable from the broken plastic piece. After the cable is free, you can use it to push the broken plastic piece out of the main tube.*

In the previous step, you removed the head of a small rivet. At this point, you can use a hammer along with a small punch (or one of the machine screws included in this kit) to press out the body of that rivet. Press from the side of the rivet where the head used to be. (If you look at this part of the main tube, you will see that one side of the curved elbow portion has several ribs cast into it but the other side has none. Lay the main tube on your workbench such that the ribs are against the surface of the bench (facing down) and then press down on the rivet with your punch. The side of the main tube that is facing up in *Figure 9* should be facing down as you press the rivet through.)

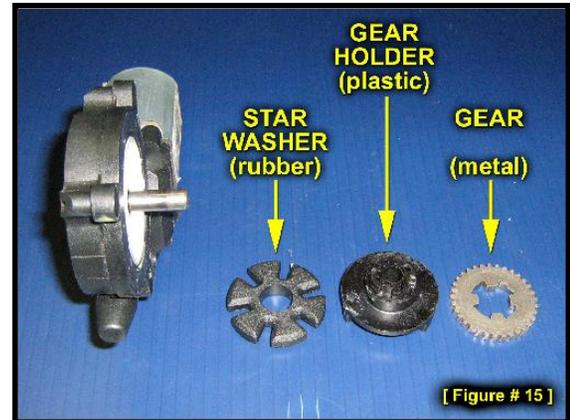
Figure 15 to the right is provided in case your motor has become disassembled further than it needed to be, and you are not sure how to put it back together. Pictured from left to right are the motor, the rubber “star washer”, the plastic gear holder and the metal gear itself. From left to right is also the order in which these items go into the motor. The rubber piece goes in first. The three legs on the bottom of the plastic gear holder slip into the slots of the rubber star washer and the metal gear goes on the plastic holder. During disassembly of the regulator, if you simply set the motor and the motor bracket aside you will not have to worry about this step. This info is provided just in case any of these parts have fallen out of your motor.

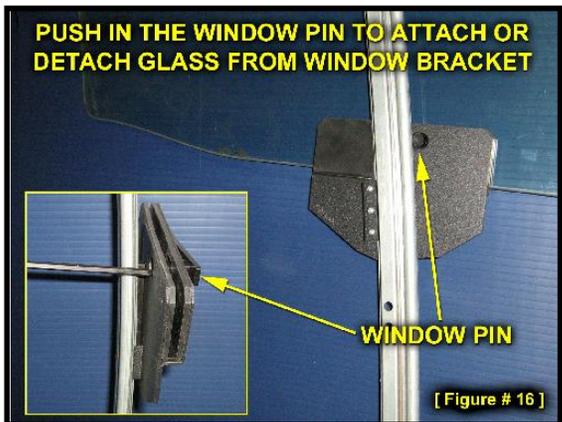
Use the window switch to position the window bracket such that you can access the window pin. Lower the glass by hand and allow it to rest on top of the bracket's window pin. While supporting the glass with one hand, use a probing tool such as a screwdriver to push on the window pin (see inset of *Figure 16*). The glass will drop down slightly and rest on the tool you used to push in the window pin. Remove the tool and allow the glass to lower to the bottom of the bracket. When the spring loaded window pin lines up with the hole in the glass, it will snap forward to lock the glass into place. Make sure that it has come forward all the way. (Note: For the sake of clarity, *Figure 16* shows the regulator and glass outside of the door, however when you attach the glass to the regulator, it will of course be inside the door.)
